O-RING FAILURE ANALYSIS

COMMON SEAL FAILURES

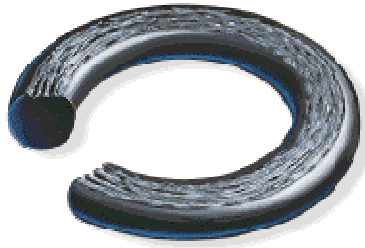
ABRASION

Description: The seal or parts of the seal exhibit a flat surface parallel to the direction or motion. Loose particles and scrapes may be found on the seal surface.

Contributing Factors: Rough sealing surfaces. Excessive temperature. Process environment containing abrasive particles. Dynamic motion. Poor elastomer surface finish.

Suggested Solutions: Use recommended gland surface finishes. Consider internally lubed elastomers. Eliminate abrasive components.

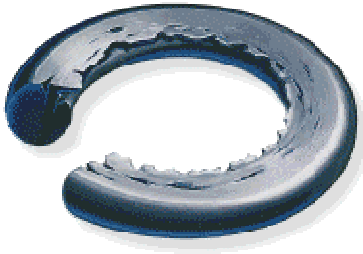
EXTRUSION

Description: The seal develops ragged edges (generally on the low-pressure side) which appear tattered.

Contributing Factors: Excessive clearances. Excessive pressure. Low-modulus/hardness elastomer. Excessive gland fill. Irregular clearance gaps. Sharp gland edges. Improper sizing.

Suggested Solutions: Decrease clearances. Higher-modulus/hardness elastomer. Proper gland design. Use of polymer backup rings.

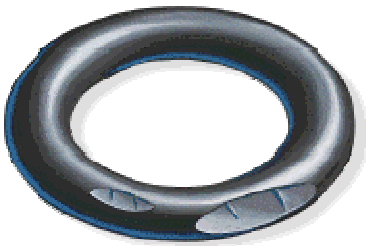
INSTALLATION DAMAGE

Description: The seal or parts of the seal may exhibit small cuts, nicks or gashes.

Contributing Factors: Sharp edges on glands or components. Improper sizing of elastomer. Low-modulus/hardness elastomer. Elastomer surface contamination.

Suggested Solutions: Remove all sharp edges. Proper gland design. Proper elastomer sizing. Higher-modulus/hardness elastomer.

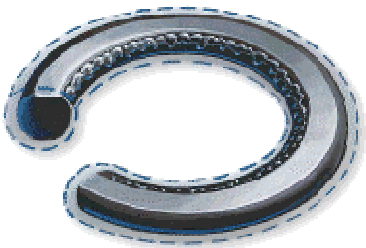
OUTGASSING / EXTRACTION

Description: This failure is often very difficult to detect from examination of the seal. The seal may exhibit a decrease in cross-sectional size.

Contributing Factors: Improper or improperly cured elastomer. High vacuum levels. Low hardness/plasticized elastomer.

Suggested Solutions: Avoid plasticized elastomers. Ensure all seals are properly post-cured to minimize outgassing.

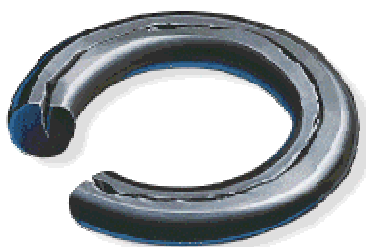
OVERCOMPRESSION

Description: The seal exhibits parallel flat surfaces (corresponding to the contact areas) and may develop circumferential splits within the flattened surfaces.

Contributing Factors: Improper design—failure to account for thermal or chemical volume changes, or excessive compression.

Suggested Solutions: Gland design should take into account material responses to chemical and thermal environments.

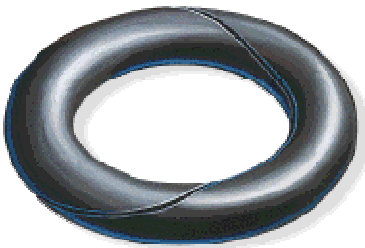
SPIRAL FAILURE

Description: The seal exhibits cuts or marks which spiral around its circumference.

Contributing Factors: Difficult or tight installation (static). Slow reciprocating speed. Low-modulus/hardness elastomer. Irregular O-ring surface finish (including excessive parting line). Excessive gland width. Irregular or rough gland surface finish. Inadequate lubrication.

Suggested Solutions: Correct installation procedures. Higher-modulus elastomer. Internally-lubed elastomers. Proper gland design. Gland surface finish of 8–16 microinch RMS. Possible use of polymer backup rings.

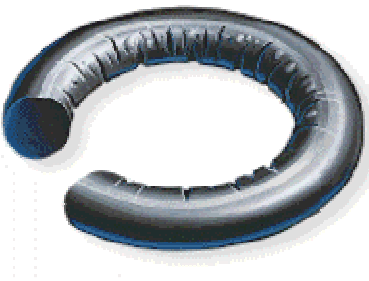
THERMAL DEGRADATION

Description: The seal may exhibit radial cracks located on the highest temperature surfaces. In addition, certain elastomers may exhibit signs of softening—a shiny surface as a result of excessive temperatures.

Contributing Factors: Elastomer thermal properties. Excessive temperature excursions or cycling.

Suggested Solutions: Selection of an elastomer with improved thermal stability. Evaluation of the possibility of cooling sealing surfaces.
