Electrostatic Purification Helps Pulp Mill Control Sludge and Varnish

A Reprint from *Practicing Oil Analysis* magazine

By DAVID M. BICKFORD, ASL TECHNOLOGIES LLC

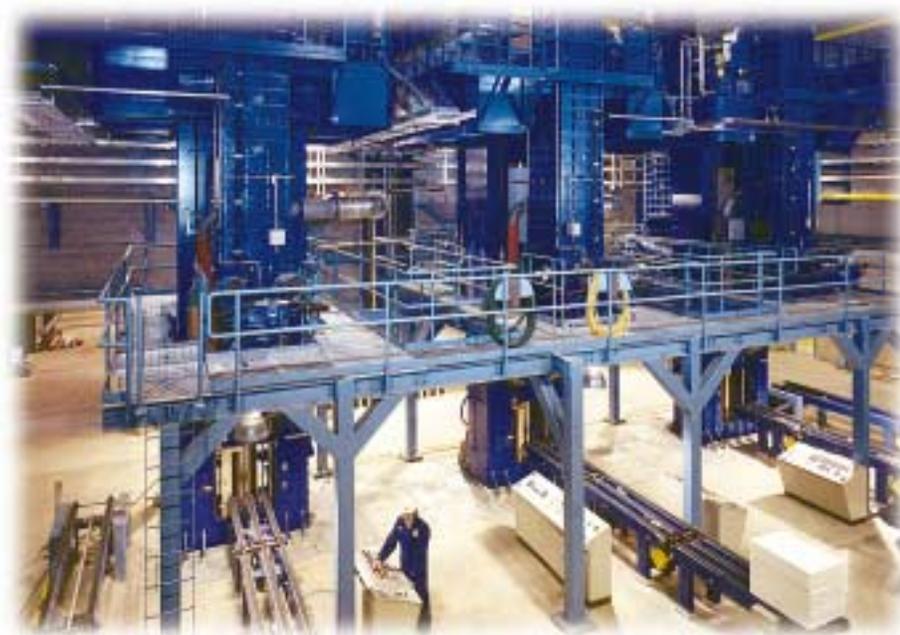
Millar Western's slab presses are high-production machines that apply 400 metric tons of force with a large vertical stamp, three or four times through each cycle.

Millar Western has three identical slab presses in its Whitecourt CTMP facility, one of which was initially targeted for the trial. The slab presses compress pulp into large, rectangular bales that are ultimately shipped out to the company's customers - paper manufacturers. Once the pulp is refined, washed and bleached, it is put through a drying process that results in a fluffy, 93 percent bone dry pulp. This dry pulp gets distributed to two storage chutes within each slab press. Each slab press is a high-production machine that applies 400 metric tons of force with a large vertical stamp, three or four times through each cycle, to compress each 225-kilogram (500-pound) bale. The cycle time to produce each bale is between 35 and 60 seconds, depending on the desired production rate, with typical hydraulic system pressures of 200 to 250 bar (2,900 to 3,600 psi).

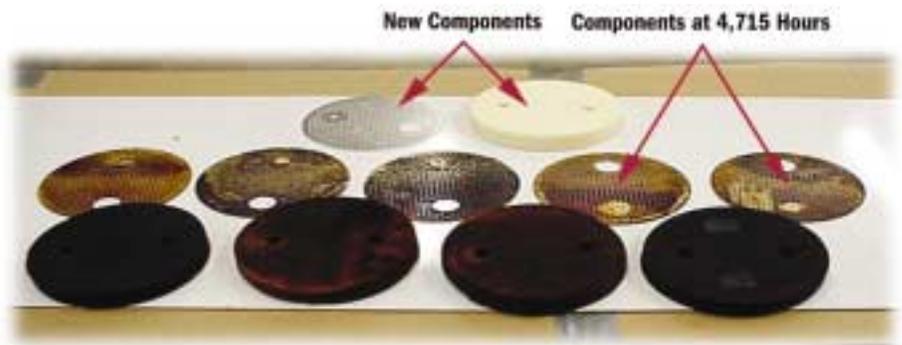
Figure 1. New and Used Electrostatic Cell Components

In this long-term test, the electrostatic filtration system operated 6,000 continuous hours without maintenance or operator intervention. Designed to operate for up to 8,800 hours before electrostatic cell remanufacture, this particular cell was torn down to show interested parties just "where the sludge and varnish went," as well as discern the remaining life of the electrostatic cell. Figure 1 shows electrostatic cell components that were removed from the test cell alongside new components. Based on thousands of electrostatic

cell rebuilds, it was determined that this cell had about 30 percent life remaining.

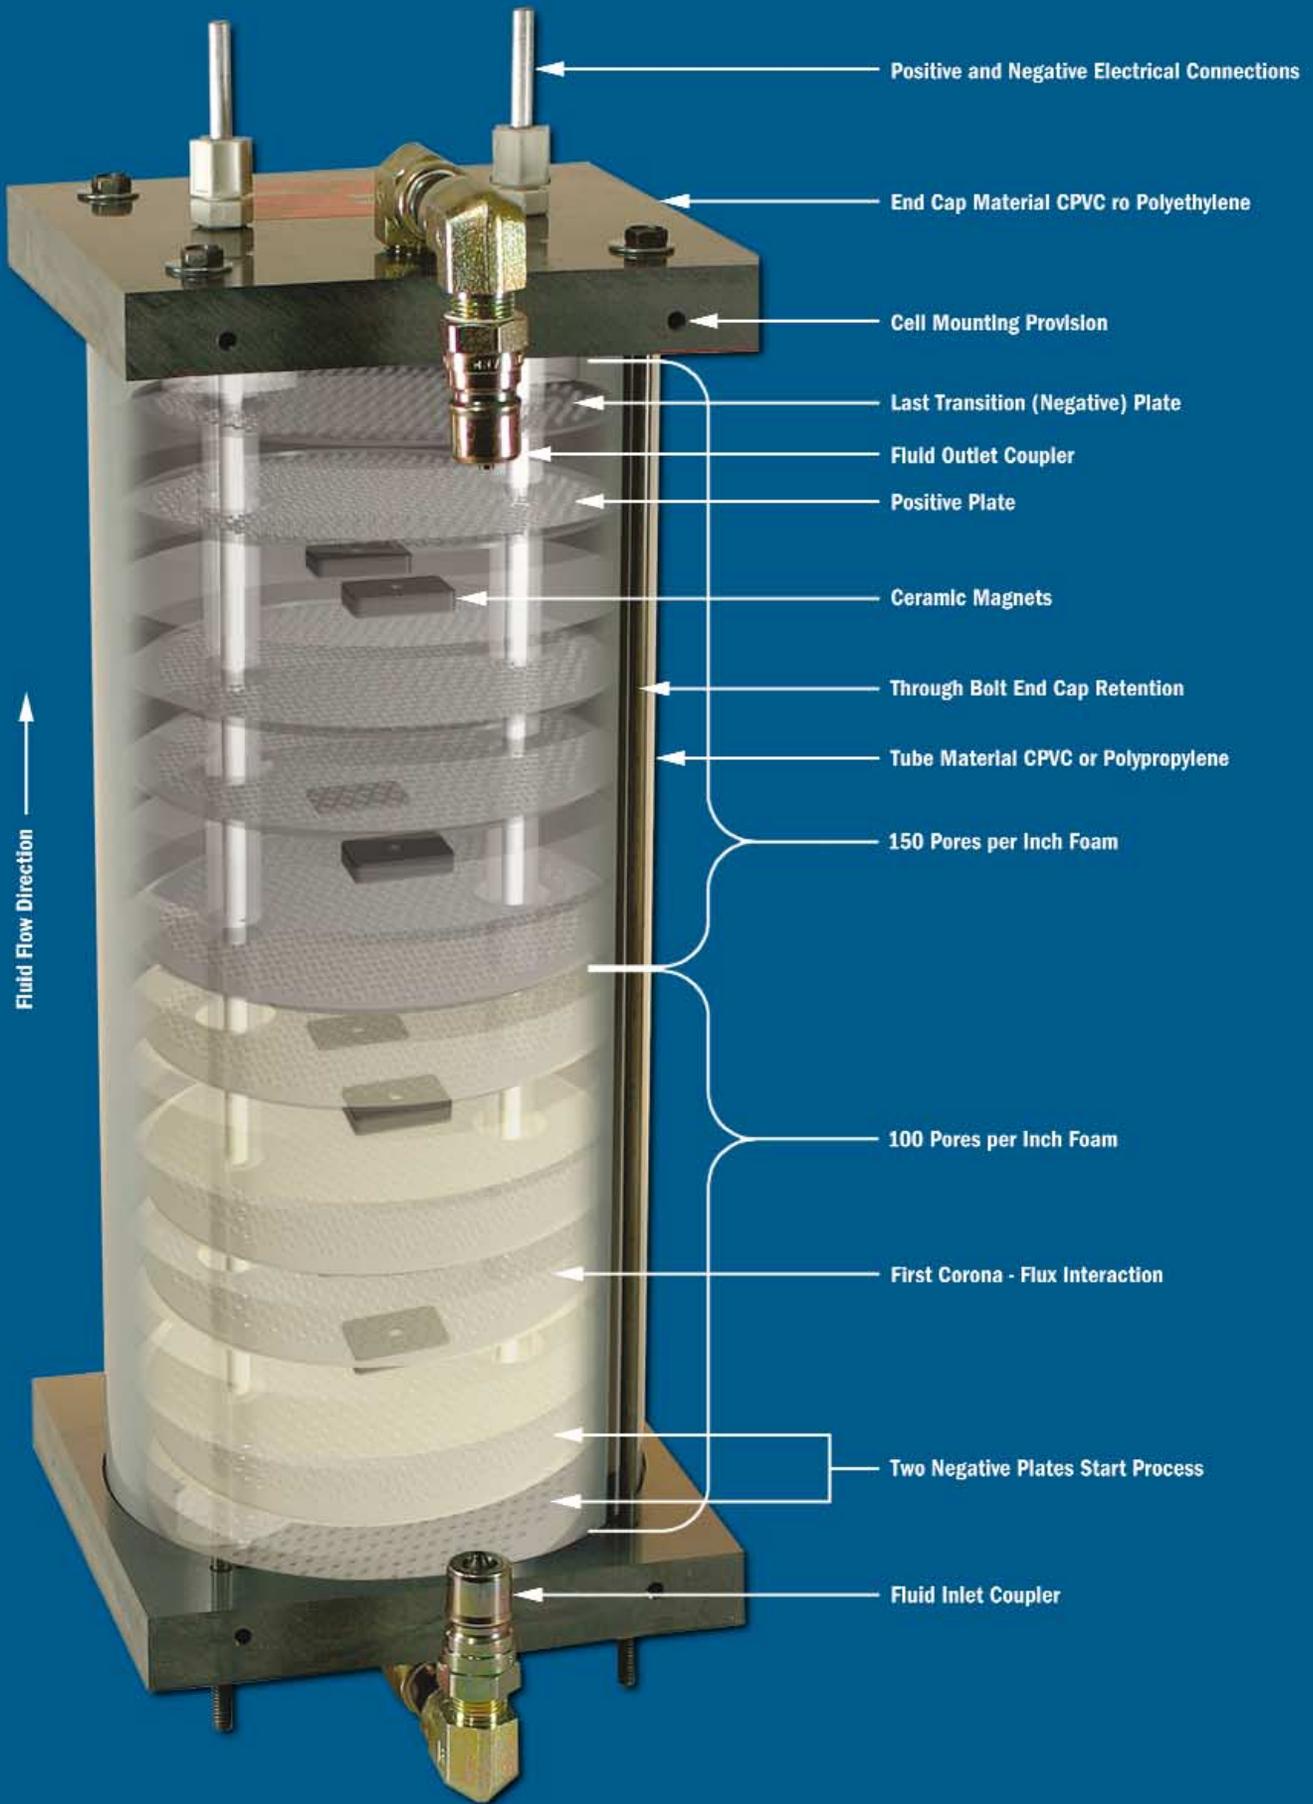
Figure 2. Electrostatic Cell Construction

The electrostatic chamber or cell is a cylindrical shell, or tube, capped with square end blocks. The necessary provisions for fluid inlet, outlet, mounting and electrical connections are located in the square end blocks.

Fluid to be cleaned first enters the cell at the bottom (Figure 2), where it collects and fills in the expansion area so that the entire cross-sectional area of the cell is exposed to the fluid. As the force of the pump moves the contaminated fluid upward, it immediately encounters the first perforated metal plate, which has a negative charge. Passing through this plate, some particles become negatively charged due to an inductive effect, and are repelled upward by coulomb forces. Many of these charged particles then remain in the pores of the filter media immediately above the plate. Likewise, any particle entering the cell that already has a negative charge is similarly repelled by the first plate, and may also become trapped.

The electrostatic chamber or cell, shown in Figure 2, is a cylindrical shell, or tube, capped with square end blocks. The necessary provisions for fluid inlet, outlet, mounting and electrical connections are located in the square end blocks.

The electrostatic cell reveals many design and manufacturing considerations. The positive and negative electrical connections, sealed by plastic compression fittings, are exposed at the top to facilitate connection to a specially designed high-voltage DC power

source via a "spark plug" terminal and rubber boot having enough length and insulating capability to shield the connections from arcing or injury.

The end caps are constructed of either chlorinated poly vinyl chloride (CPVC), for use with the more common types of hydraulic, turbine and lubricating oils, or polyethylene when filtration of phosphate ester fluids is desired. These materials are relatively inexpensive, easily machined and have little difficulty withstanding temperature ranges typically seen in most systems. To seal the end caps to the tube, O-ring grooves are machined into the caps.

Commercial quick-disconnect couplings are used to minimize external contaminant ingress and ease installation and system maintainability. Threaded holes on both sides of the end caps provide secure mounting points for the electrostatic cell. Simple threaded through bolts retain the end caps to the tube, and are affixed with positive locking nuts. Like the end cap,

the tube is made of PVC, or polypropylene when phosphate ester fluids are filtered.

The electrostatic cell depicted in Figure 2 is approximately 20 inches tall, with 7.25-inch square end caps, and weighs approximately 16 pounds dry. A single cell can operate at flow rates of approximately 40 GPH. Using the preferred formula of one reservoir cycle every 24 hours, a single cell system, with a 40 GPH pump, can support a reservoir of approximately 1,000 gallons or less. The unit is scalable such that on larger systems requiring higher flow rates, multiple cells can be connected in parallel. A reservoir of roughly 2,000 gallon capacity would require a single pump and motor of 80 GPH capacity and two of the cells pictured in Figure 1. Depending on plumbing complexity, multiple cells can effectively filter reservoirs of unlimited capacity. The largest such system built to date with this unit is a 24 cell 1,000 GPH system, supporting a 22,000 gallon turbine oil reservoir.

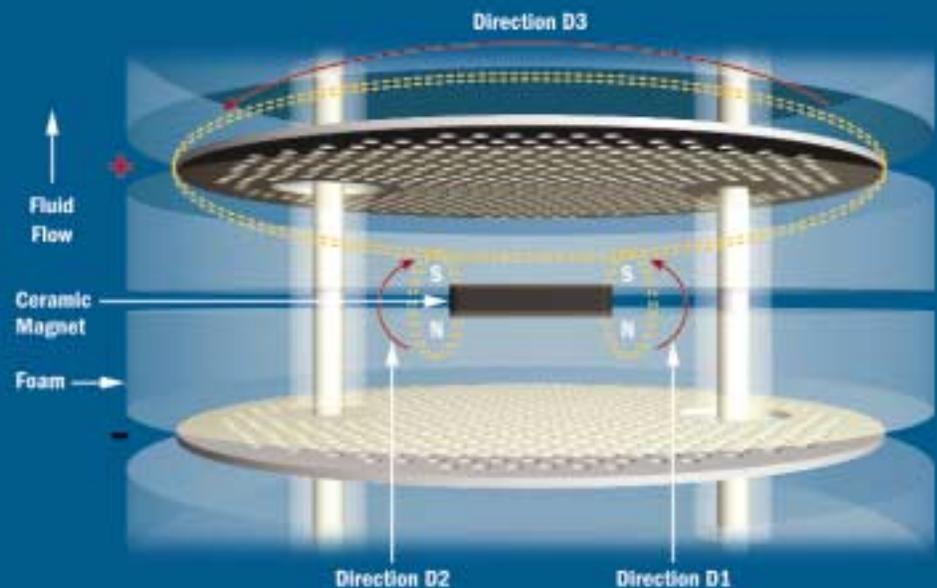
Figure 3

Permanent ceramic magnets suspended between the negative and positive plates form a toroidal flux field, acting in directions D1 and D2 (relative to fluid flow). This toroidal flux field interacts with the counterclockwise (D3) corona formed around the positive plate. As particles suspended in the fluid enter the resultant force field, the turbulence created by the interaction of these force fields causes random agitation of the particulate, causing it to become embedded within the micropores of the foam.

Different effects at different locations in the force fields tend to create greater random agitation, as the particles are accelerated at some places and resisted at others. This not only makes entrapment of submicronic sludge, varnish and oxidation by-products achievable, but also effectively doubles the holding capacity of the electrostatic cell. A microammeter connected to the cell shows the relative amount of power required to hold particulate in suspension.

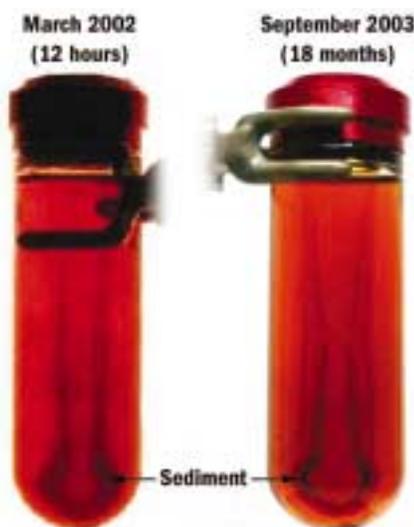
Figure 4. Ultracentrifuge Images from Slab Press

The oil samples pictured in Figure 4 also verify that the varnish problem is being effectively managed. The image on the left is the oil sample that was taken 12 hours after the electrostatic purification system was installed. The oil sample on the right was taken in September 2003. These samples clearly show there has been no increase in suspended solids since the trial began 18 months earlier. If anything, a slight reduction in suspended solids is visible.

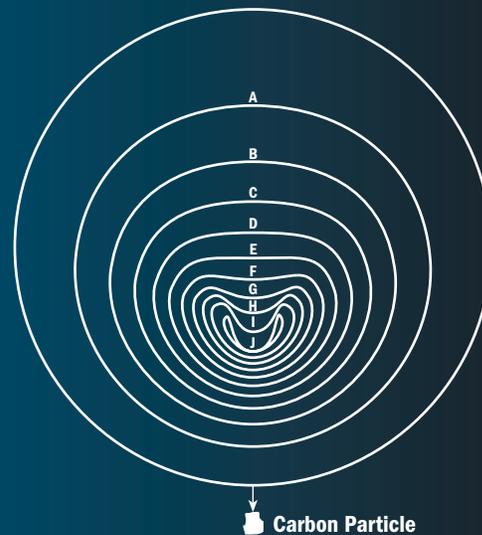
Boyle's Ideal Gas Law

Zone	Pressure	Temperature
A	Atmospheric (Pump Inlet)	100°F
F	1,000 psi	1,410°F
H	2,000 psi	1,820°F
I	3,000 psi	2,100°F

Any entrained air bubble in a system that is drawn into the suction side of the pump will be compressed. As anyone who has used a hand-operated bicycle pump will know, compressing air or any gas causes an increase in temperature: the change in temperature with pressure change is governed by Boyle's Law. According to this fundamental law of physics, compressing a gas from atmospheric pressure (the reservoir) to 2,000 psi or more (the discharge side of a high-pressure pump) will result in an increase in temperature from perhaps 100°F to more than 1,800°F, enough to turn any oil into carbon particles similar to soot - the result of burning diesel fuel at elevated temperatures. While this extreme temperature is found only in a localized area around the compressed gas bubble, over time, a significant degree of oil degradation can occur. In rolling contacts such as large rolling element bearings, where elastohydrodynamic lubrication is the norm, the situation can be even more severe with instantaneous pressures of hundreds of thousands psi.
