APPLICATION REPORT

PUMP MODEL

B4002AABBTTA (Aluminium / PTFE)

Industrial Paint

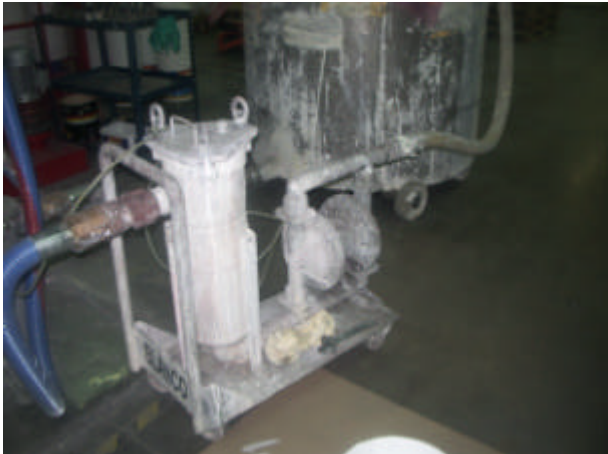
Industrial paint mixing. This 1.5" pump was trolley mounted for moving around the facility, pumping at multi-station paint transfers.

DUTY	Industrial Paint	FLOWRATE	N/A
HEAD	N/A	AIR PRESSURE	3 bar

Flooded suction.
